# **HORSESHOE RESERVOIR HABITAT RESTORATION STUDY**

**Final Report Prepared for the Salt River Project and The Nature Conservancy  
January 6, 2023**

**Prepared by  
Tice Supplee (National Audubon Society) and Mark Briggs (New River/New World  
Consulting)**

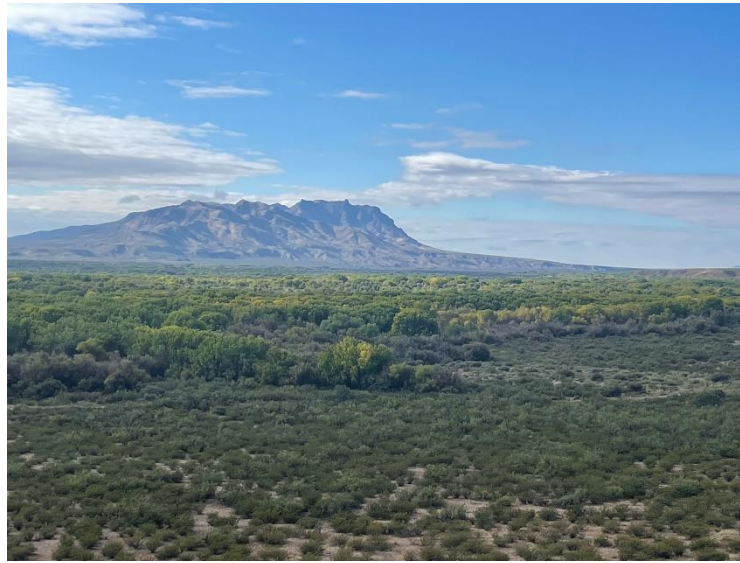
Figure 3. Photograph of the extensive obligate riparian plant community that has established on over 40 km (25 miles) of the MRG reach upstream of the Elephant Butte Reservoir.

First, the extensive high-quality native bottomland habitat in areas dominated for numerous years by the imposed hydrologic environment of Elephant Butte Reservoir underscores just how dramatic and rapid the reestablishment of native habitat can be when natural processes return. Although the two settings – Horseshoe Reservoir along the Verde and Elephant Butte Reservoir along the Rio Grande – differ with regard to their biophysical characteristics, the rapid reestablishment of high-quality native habitat in the Elephant Butte delta is nonetheless heartening to the prospects of restoring native bottomland plant communities at Horseshoe Reservoir.

The second take home from the Elephant Butte Reservoir experience is that the rapid reestablishment of native habitat just upstream of the reservoir occurred without active management intervention by the US Bureau of Reclamation or anyone else. The native obligate riparian plant community reestablished naturally as the reservoir retreated. Looking ahead in this report to the restoration sites proposed at Horseshoe Reservoir, the above lessons are possibly more apropos for Restoration Site A, which, being the upstream most restoration site, is where natural streamflow processes are likely to strongly reestablish if Horseshoe Reservoir management becomes dominated by run-of-river management. The experience at Elephant Butte underscores how the return of natural flow processes at reach scale has great potential to foster natural regeneration of native bottomland habitat.

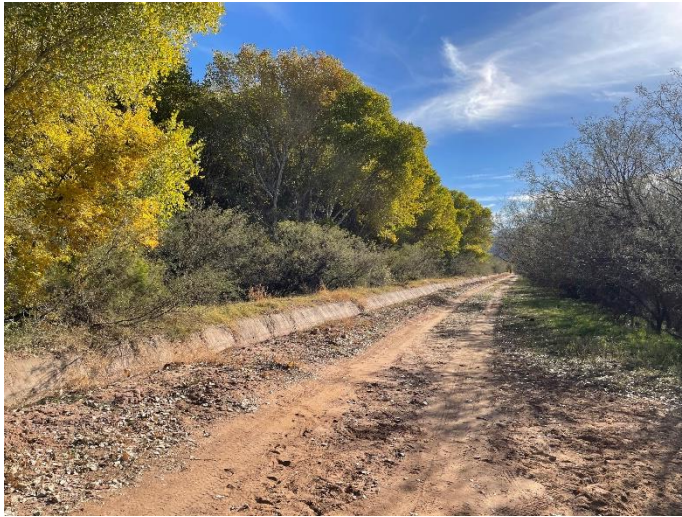
Figure 6. Photograph of a mature stand of dense cottonwoods and willows at the Rockhouse Demonstration site attest to the effectiveness of revegetation actions to establish habitat for key bird species (photograph taken December 2022).

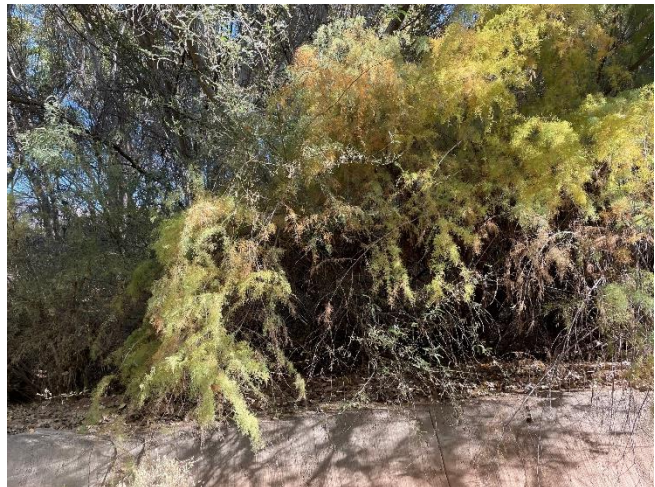
Figure 7. Photograph of scattered non-native saltcedar has established at the Rockhouse site, though the high density overstory of cottonwoods and willows has shaded out and prevented significant expansion of this invasive species at this site. Establishing a high density overstory to thwart expansion of non-native species is a potential applicable lesson for future revegetation efforts at Horseshoe Reservoir.

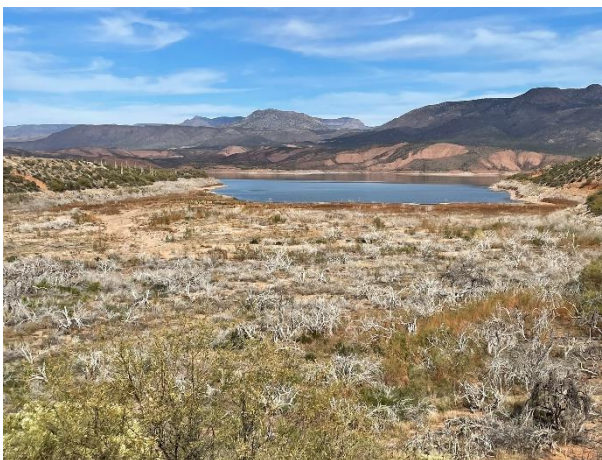
Figure 8. Photograph of a part of the southern shoreline along Roosevelt Reservoir underscores the challenges of that frequent periods of prolonged inundation followed by retreat of the reservoir pool pose to vegetation establishment.

Harsh shoreline zones relatively free of vegetation was a characteristic in many other parts of Roosevelt Reservoir. For example, at the Orange Peel site along the shoreline where Tonto Creek meets the Reservoir edge; prolonged periods of inundation followed by periods of reservoir pool retreat have created conditions where even many invasive non-native species cannot survive (Fig. 8). At Horseshoe Reservoir, shoreline sites that were frequently inundated under past management could become suitable to the establishment of desirable native bottomland habitat under run-of-river management that reduces the frequency and duration of inundation. Planting desirable plants at such sites will need to be done carefully, taking into consideration a variety of factors, including the rate of drawdown to allow plant root systems to follow retreating saturated soil levels.

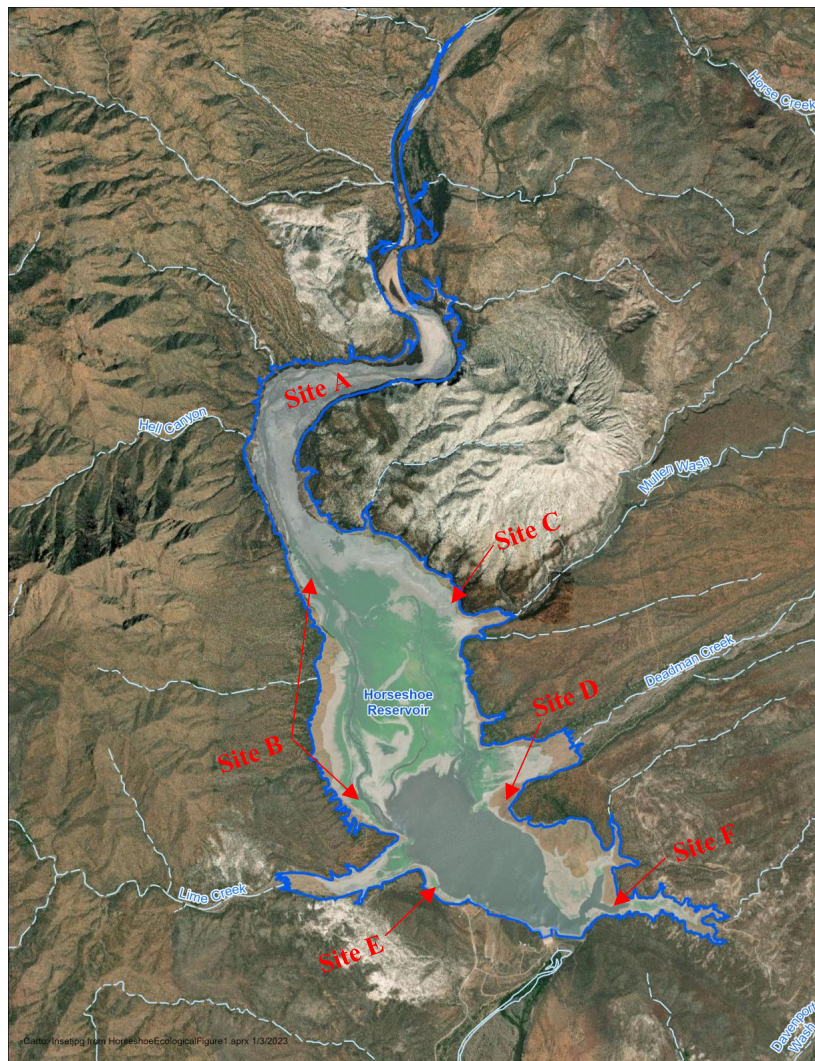
Figure 9. Overview image of Horseshoe Reservoir showing locations of proposed restoration sites A-F (image provided by SRP Cartographic & GIS Services).

Six sites (A-F) have been identified in Horseshoe Reservoir as having potential for establishing native bottomland plant communities in a future dominated by run-of-river management (Fig. 9).

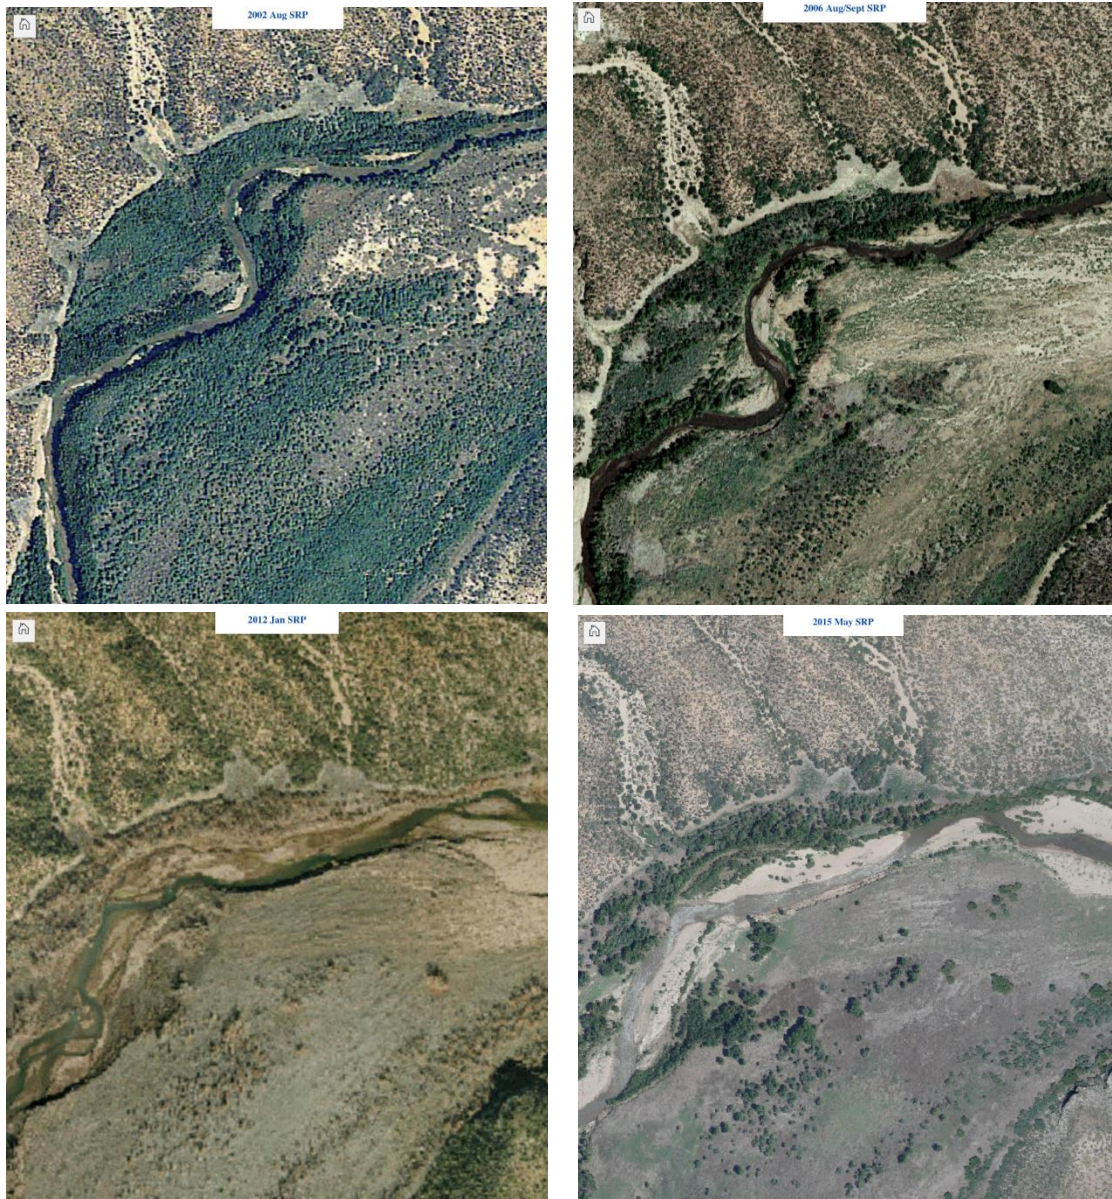
Figure 10. Google Earth aerial images of the central portion of Restoration Site A in August 2002, August 2006, January 2012, and May 2015. Morphologic changes in the Verde River channel between these different time periods are evident (particularly when images of August 2006 and January 2012 are compared) and likely as a result of high flows that occurred during 2008 and 2010.

hydrologic cycles (Fig. 10). Periods of dynamic morphologic and riparian vegetation change take place with the occurrence of high magnitude flow events of sufficient duration to perform dramatic channel work as alluvium is scoured and evacuated from one part of the channel and deposited along downstream reaches. Such a dynamic environment fosters a channel physical template ideal for the establishment of a natural, patchy riparian plant community dominated by native vegetation and is the central reason why Site A was selected as a restoration site.

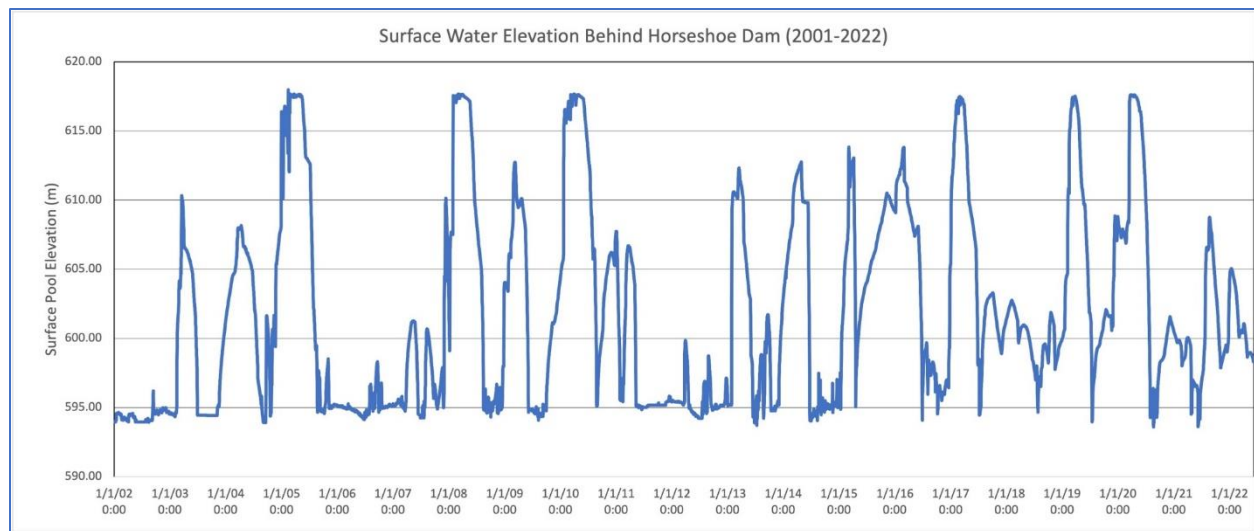
Figure 11. Surface water elevation of Horseshoe Reservoir pool for years 2001 to 2022. During this period, the reservoir pool reached and was held at conservation pool status six times for several weeks to over a month (surface water elevation data provided by SRP).

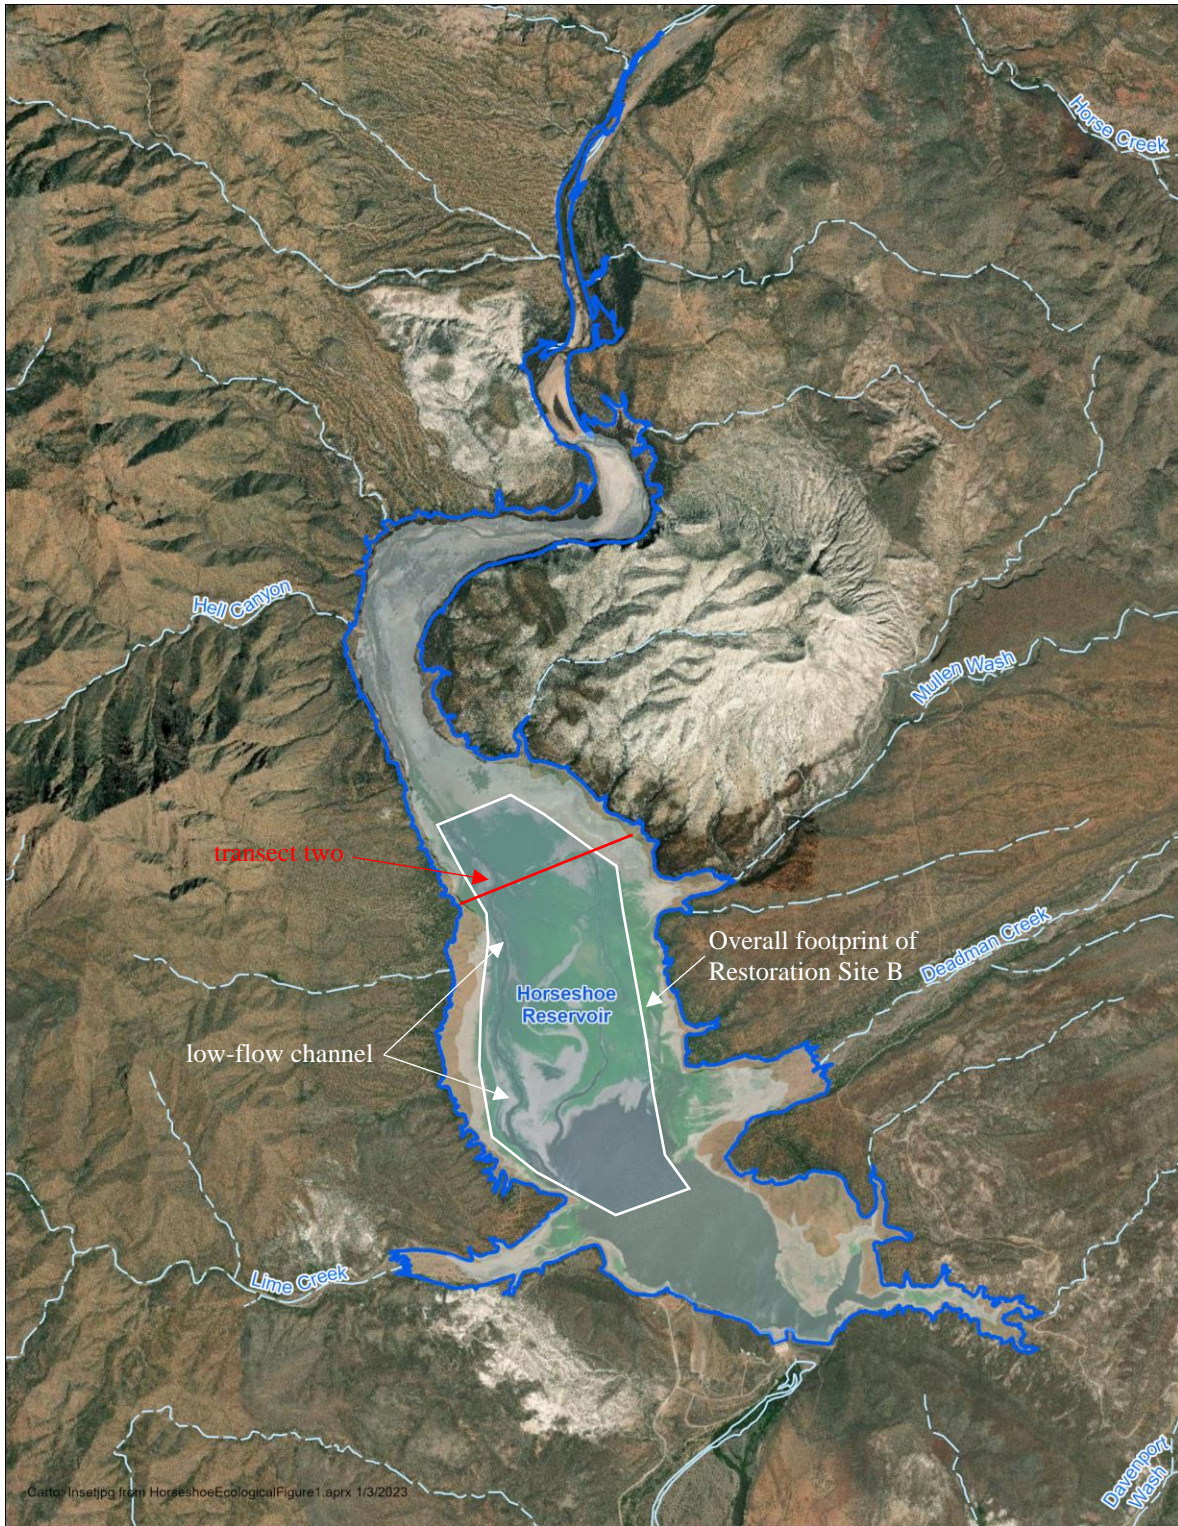
Figure 14. Image of Horseshoe Reservoir showing overall footprint of Restoration Site B and location of transect two. The backbone of Restoration Site B is the low flow channel.

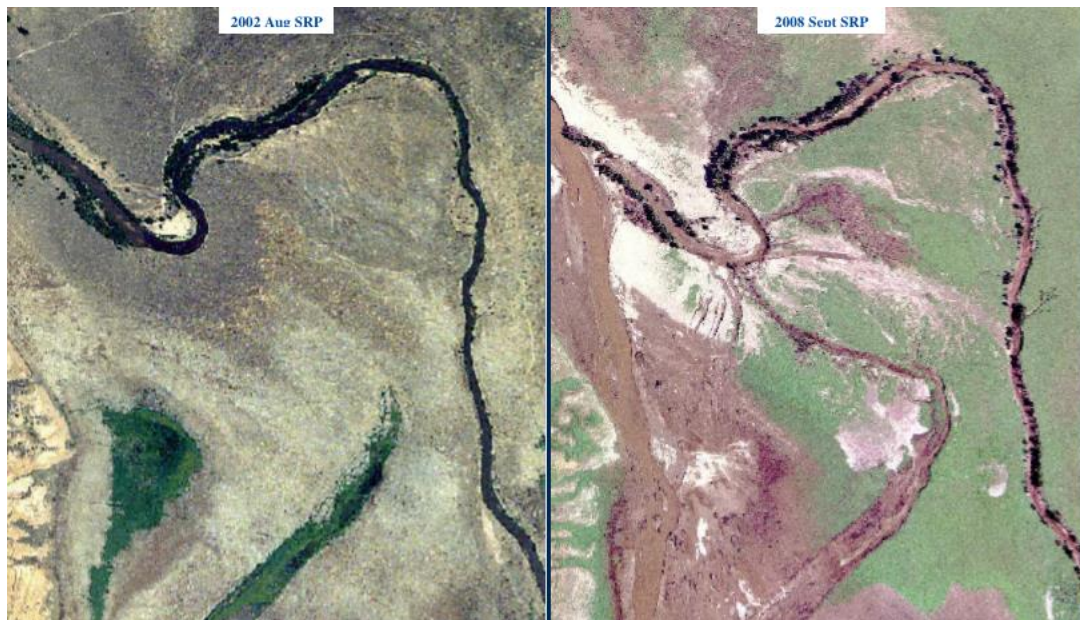
Figure 15. A comparison of aerial photography between 2002 and 2008 at Restoration Site B that shows the formation of a sediment plug that likely impeded flow in the eastern Horseshoe Reservoir low-flow and led to establishment of the current low-flow channel that heads due south. The establishment and persistence of trees along the channel is clearly demarcated in the 2008 photograph (images provided by SRP Cartographic & GIS Services).

In this regard, the fact that willows naturally established within the footprint of Restoration Site B is important. The take home point being that, even under past management of Horseshoe Dam, sweet spots along the riparian stability continuum were naturally ‘found,’ with willows establishing and persisting for almost two decades. This is borne out by examining the locations of past low flow channels within Horseshoe Reservoir and noting willow establishment along them. Active low flow channels of the recent past appear as ghost relicts that trace the path of past channel migration across the reservoir valley in response to processes of sediment evacuation and deposition during moderate to high Verde River flow events (Fig. 15). Once a given channel thalweg (or active low-flow channel) has incised sufficiently into valley sediments to capture flow, it will receive the majority of Verde River low flow until alluvial depositional processes occur to impede flow, forcing abandonment and the formation of an entirely new low flow channel. Such a scenario likely occurred during high flow events of 2008 and led to the quasi-abandonment of the low-flow channel on the eastern side of the reservoir to the present position of the low-flow channel on the western side of the reservoir (Fig. 15).

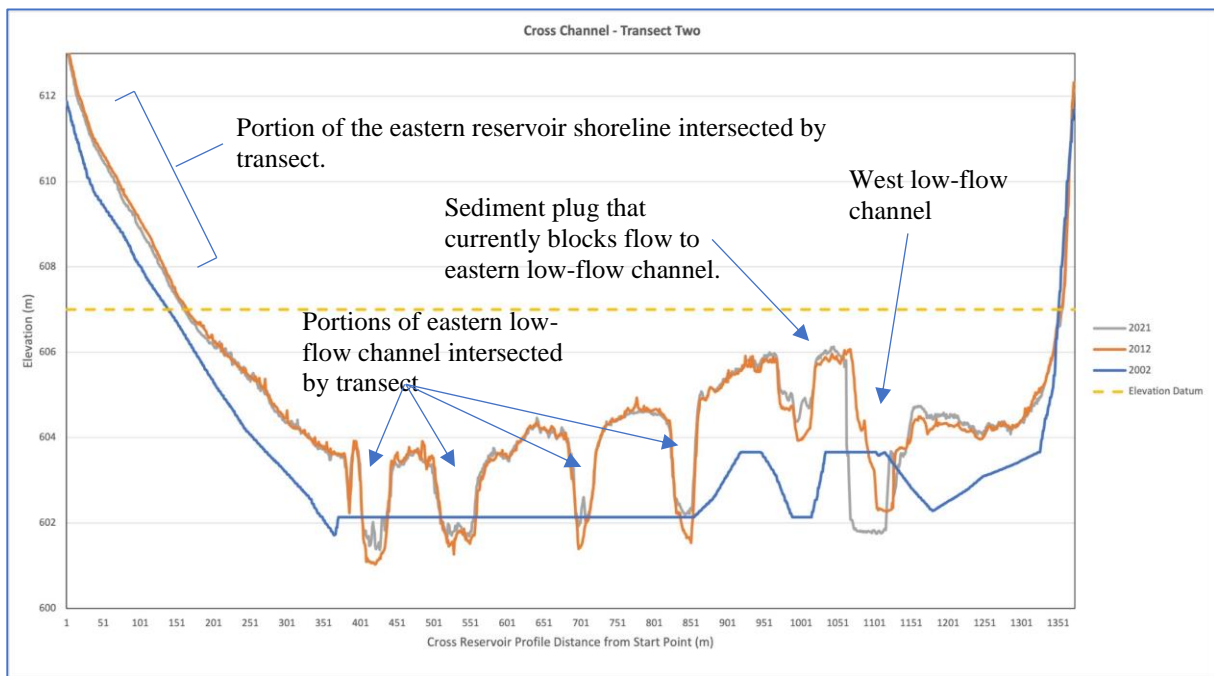
Figure 16. Graph of elevation change across transect two (see Figure 14 for transect location), which extends west to east across the reservoir at the northern portion of Restoration Site B. In this location, the transect cuts across both the current low-flow channel on the western side of the reservoir and multiple parts of the former low-flow channel on the eastern side of the reservoir. Elevation data were developed from remote LiDar (2012 and 2021) and multispectral imagery platforms (2002). Note only subtle morphologic changes between the years 2012 and 2021 (see also Table 2).

<b>Transect Two Parameter</b>	<b>2002</b>	<b>2012</b>	<b>2021</b>
Channel (or Reservoir) Cross-Section Area Under Elevation Datum (m2)	na	3,359.7	3,386.6
Percent of points w vegetation > 0.3m in height along the low-flow channel within Site B (376m - 1201m from starting point)	na	24.5	8.5
Percent of points w vegetation > 0.3 m in height outside the low-flow channel (200m - 360m from transect starting point)	na	0.6	0

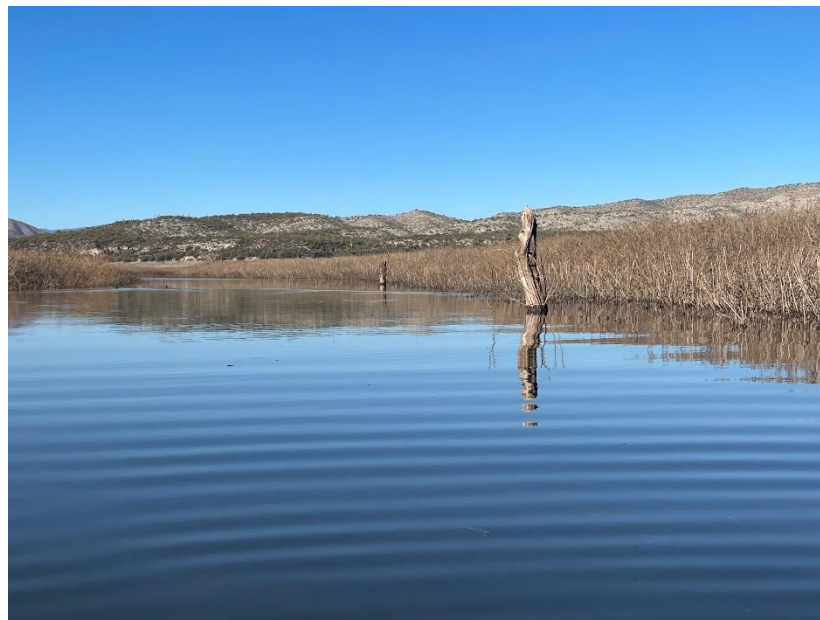
Figure 17. Photograph of dead willows snags within the footprint of Site B near the mouth of Mullen's Wash. These trees likely succumbed from the combined impacts of desiccation (possibly as a result of the sediment plug that blocked low flow to this portion of the reservoir) and prolonged inundation.

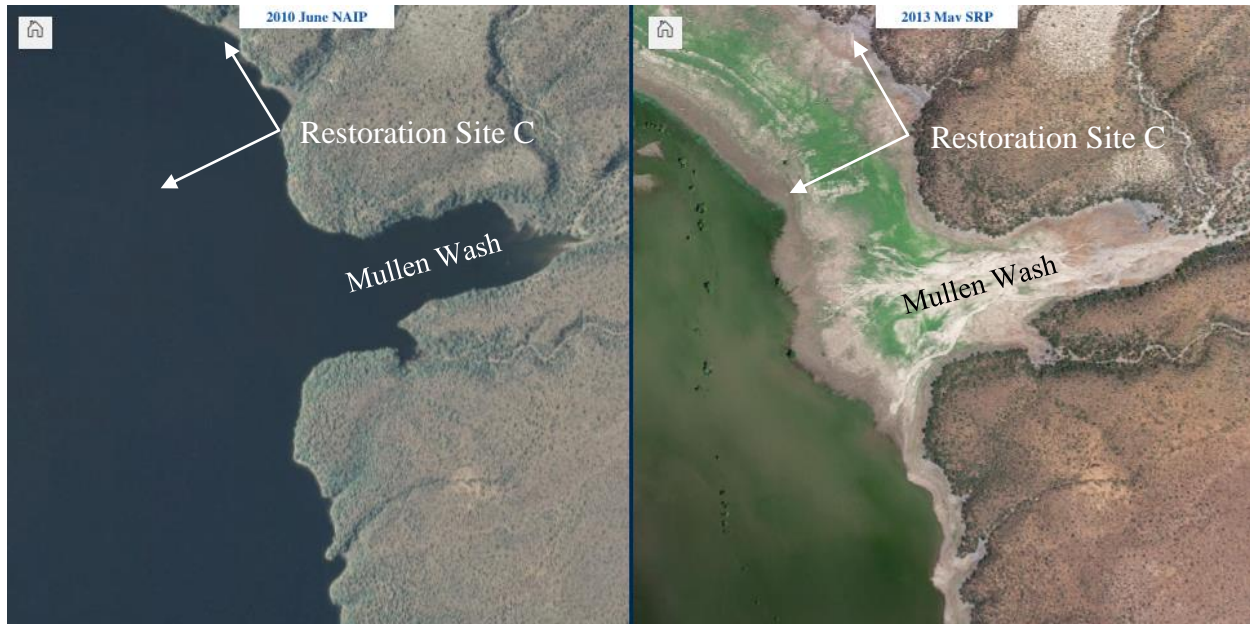
Figure 19. Aerial photographs of the southern portion of Restoration Site C just north of mouth of Mullen Wash. The majority of this site was inundated by impounded waters behind Horseshoe Dam about 12% of the time (as depicted in aerial photograph of June 2010 (left)). The reservoir shoreline that comprises the restoration site is clearly shown in aerial of May 2013 (right).

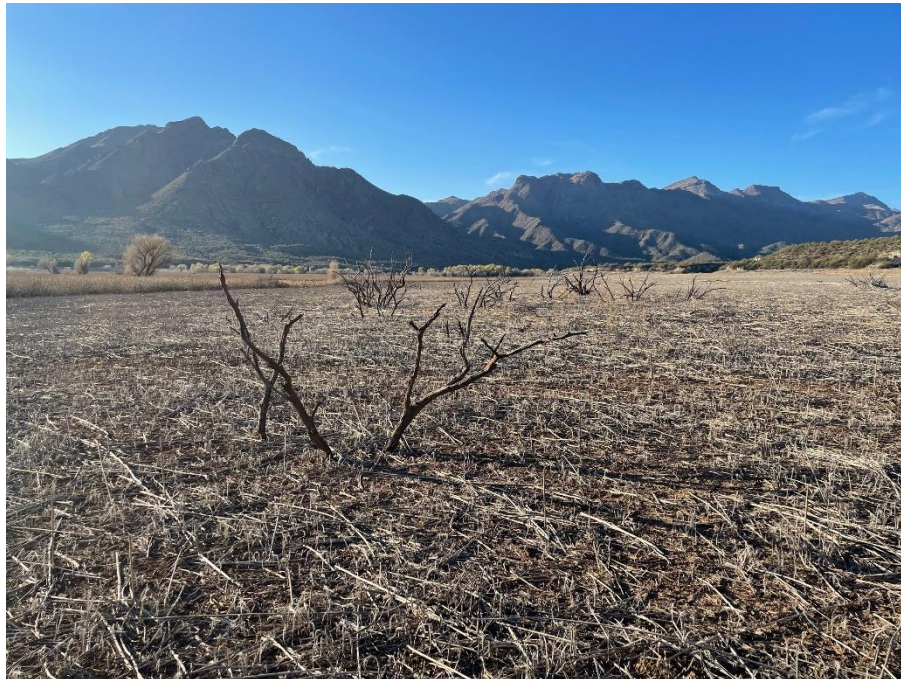
Figure 20. Photograph of Site C surfaces just upstream of the mouth of Mullen’s Wash. Dead willows scattered in a sea of dead *Amaranthus palmeri* underscore the harshness of an environment affected by frequent and prolonged inundation by the Horseshoe Reservoir pool as well as by periods that leaves these surfaces high and dry for extended periods of time.

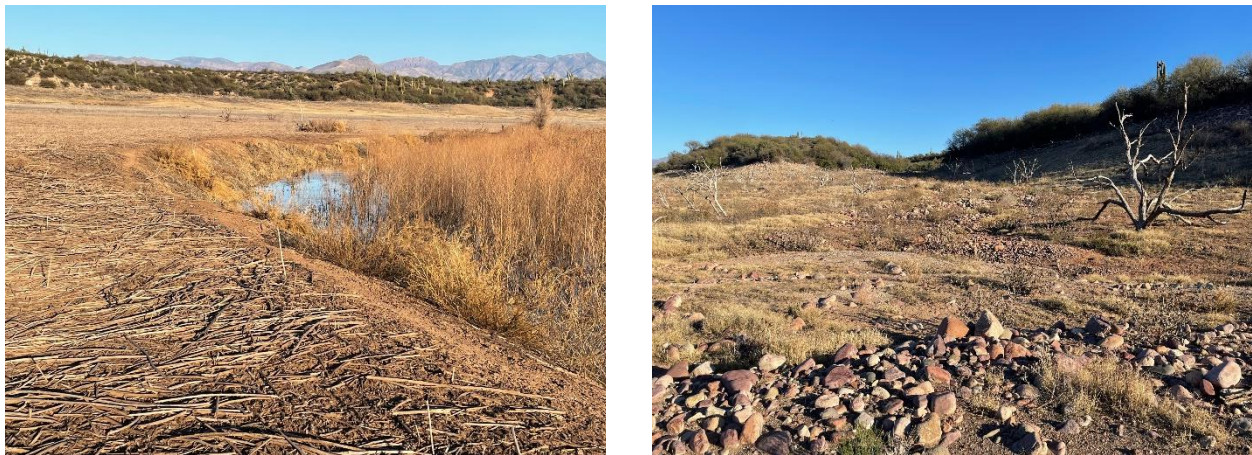
Figure 21. Two photographs showing surfaces of high potential for the establishment of native bottomland plant communities at Site C. Photograph on the left is just north of the mouth of Mullen's Wash and shows two potential planting surfaces that differ in elevation of just over one meter. The lower elevated surface (with water indicating the elevation of the reservoir pool at the time the photo was taken) currently supports *Salix exigua* (coyote willow) and may so in the future even under run-of-river management. Higher elevated surfaces may be conducive to the establishment of native non-obligate riparian plants. Dead willows (likely *S. gooddingii*) in the background on the photo on the right appear established in the past 'sweet spot' of the riparian stability continuum. At least for a brief period of time (maybe five years) before their demise, these surfaces supported willow establishment with characteristics that provided protection from flood scour while also providing sufficient water availability. Mapping these surfaces should be a priority to inform where native bottomland plants could be successfully established in the future.

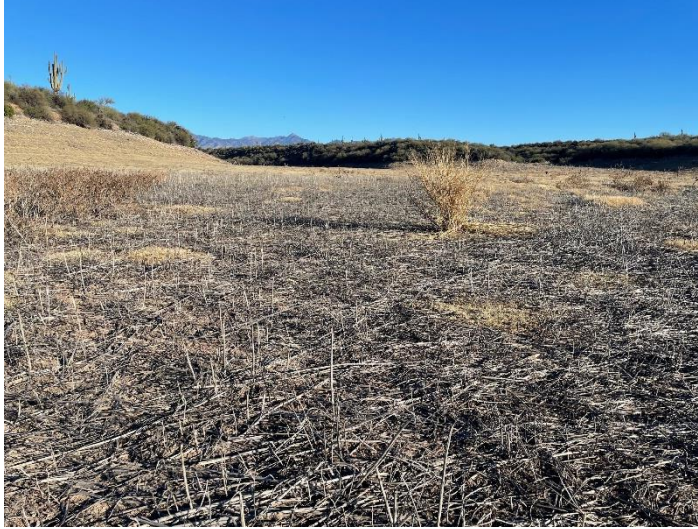
Figure 23. Photograph of a part of Restoration Site C just north of the mouth of Mullen’s Wash. One *Sporobolus wrightii* (giant sacaton) has established in the midst of a dense matt of dead *Amaranthus palmeri*, indicating one native species that could be a viable component of future native bottomland plant establishment.

If run-of-river becomes the future management norm, the frequency and duration that Restoration Site C will be inundated by waters impounded behind Horseshoe Dam will likely decline along with the buffering effects that inundation has on tributary outflows. From the standpoint of restoration, the return of natural hydrology cycles is of great benefit to native flora and fauna. It will be fascinating to observe biophysical change at this site once run-of-river management is implemented. Indeed, what we are advocating in the near-term is to develop a realistic (from standpoint of funding, equipment personnel needs) and thoughtful monitoring program for this site that allows quantification of change and an effective adapted management response that may include targeted revegetation with appropriate native species and targeted management actions to reduce the extent and distribution of non-native plants (Fig. 23 and Table 4).

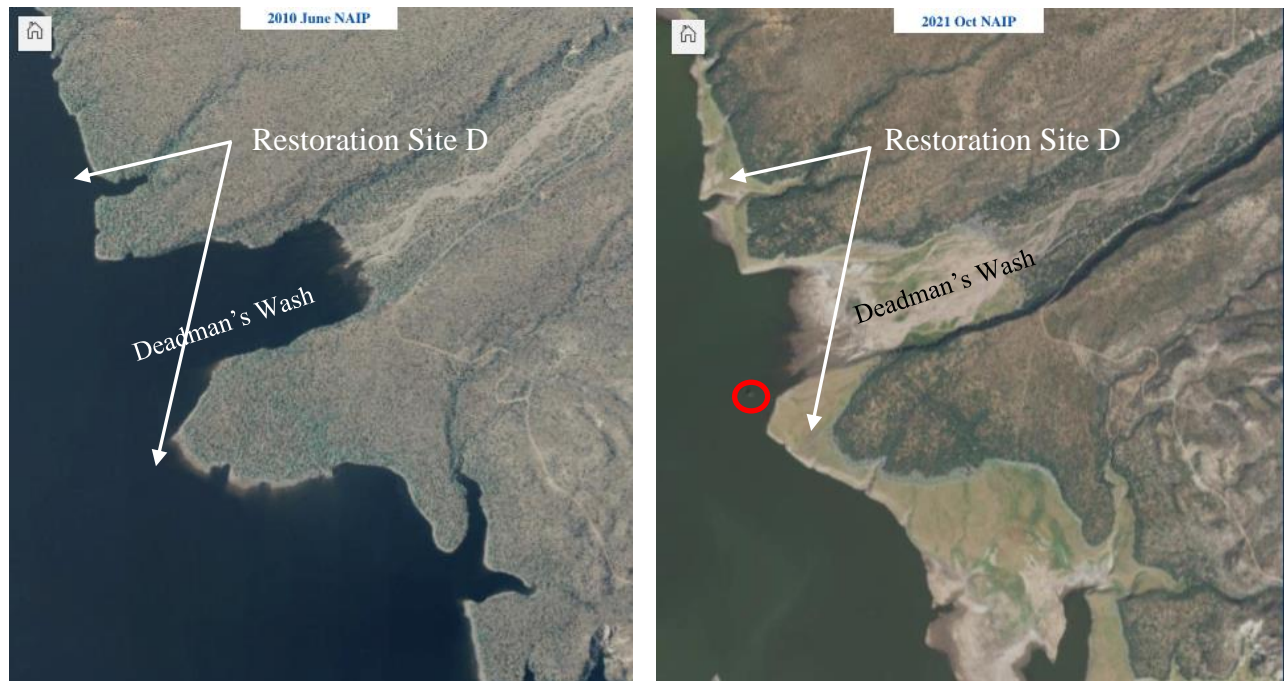
Figure 24. Aerial photographs indicating location of low-lying shoreline surfaces just north and south of the mouth of Deadman's Wash that comprise the majority of Restoration Site D. A comparison of aerial photography between June 2010 and October 2021 underscore frequent inundation of these surfaces under past management of Horseshoe Dam. The red circle in the 2021 aerial photograph indicates position of the cluster of *S. gooddingii*, which is highlighted further in Figure 26.

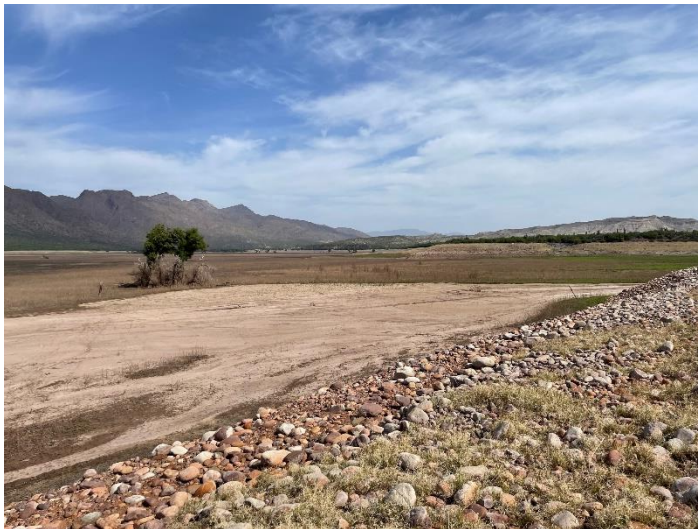
Figure 25. Photograph of Restoration Site D reservoir shoreline surfaces just to the south of the mouth of Deadman's Wash (middle portion of the photograph). Dramatic swings in water availability - between frequent and prolonged periods of inundation and pool retreat – have left these surfaces relatively free of vegetation.

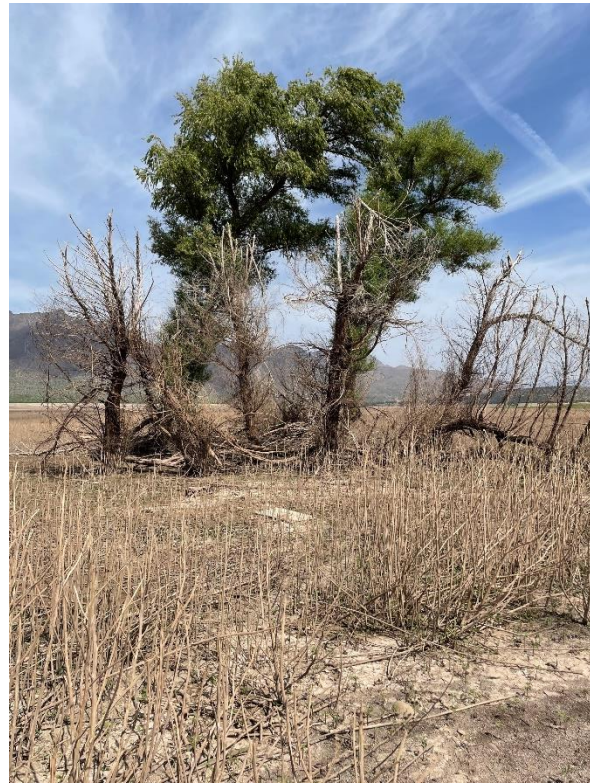
Figure 26. Photograph of a mature *S. gooddingii* near the mouth of Deadman's Wash provide evidence that obligate riparian trees were able to establish and persist at this site for numerous years. The dead willows surrounding the one remaining live willow likely succumbed as a result of desiccation when reservoir pool retreat was sufficiently dramatic to drop the zone of soil saturation below the root zone. Invasive, annual *Amaranthus palmeri* surrounds the willows.

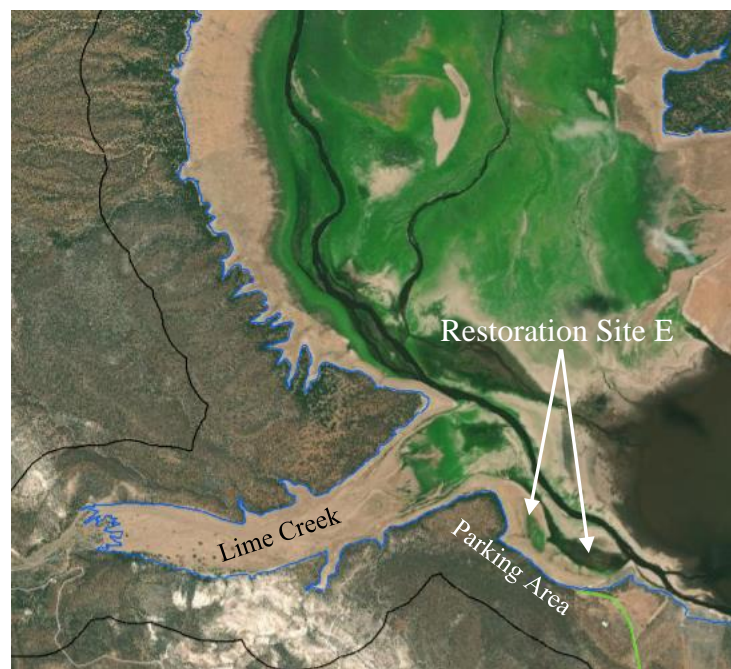
Figure 28. Aerial photograph showing the mouth of Lime Creek with potential planting sites and visitor parking area (indicated with arrows) constituting the heart of the restoration objective for Site E. The southern most arrow points directly at the shoreline inlet discussed in text below. The blue line delineates the elevation of the conservation pool (i.e., when the elevation of surface waters behind Horseshoe Dam are at 617.7 m (2,026 ft)).

Restoration Site E encompasses surfaces that are located along the western shoreline of Horseshoe Reservoir just to the south of the mouth of Lime Creek (Figs. 9 and 28). This is a popular site for visitors to Horseshoe Reservoir with the flat, upper portions of the site being an area where visitors frequently park.

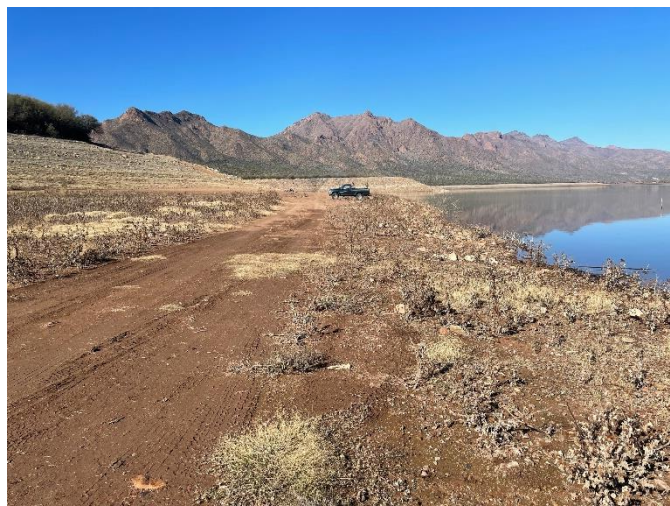
Figure 29. Photograph of Restoration Site E surfaces that may be conducive to the establishment of non-obligate riparian plant community in a park-like setting. Under current management, this area is frequently used by visitors to Horseshoe Reservoir as an access point for recreation.

appropriate for higher elevation surfaces (up to and including the flat surface where visitors often park) (Fig. 29). Along the shoreline of the reservoir south of the mouth of Lime Creek, conditions may be suitable for obligate riparian plants. This may be particularly true toward the southern portion of the site where an inlet into the shoreline is located and whose lower elevation appears conducive to holding waters for extended periods of time following the retreat of the reservoir pool (Fig. 30). The extent that such would occur under run-of-river management is unknown at this point but can be better ascertained with hydrologic modelling similar to what is emphasized in Section Five. If inlet water availability does prove to be appreciably higher under run-of-river management, such may offer conditions appropriate for the establishment of obligate riparian and/or emergent native plants. Regardless, native plant establishment at this site would emphasize non-obligate riparian species on higher elevated surfaces (Fig. 31).

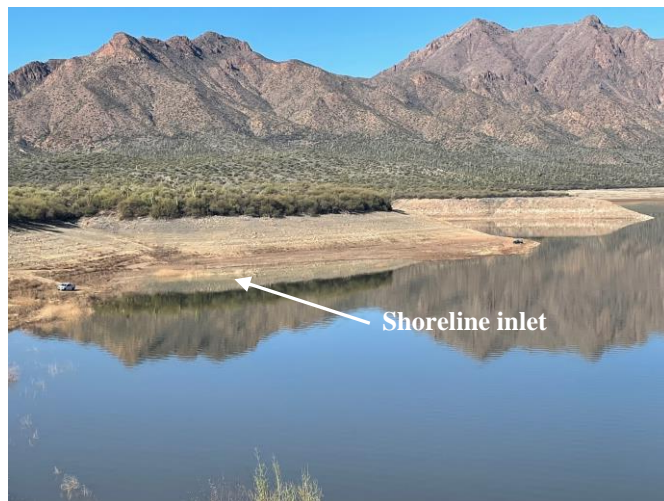
Figure 30. Overview photograph of Restoration Site E showing surfaces currently used for parking (note the two pickups in the photograph) as well as the shoreline inlet.

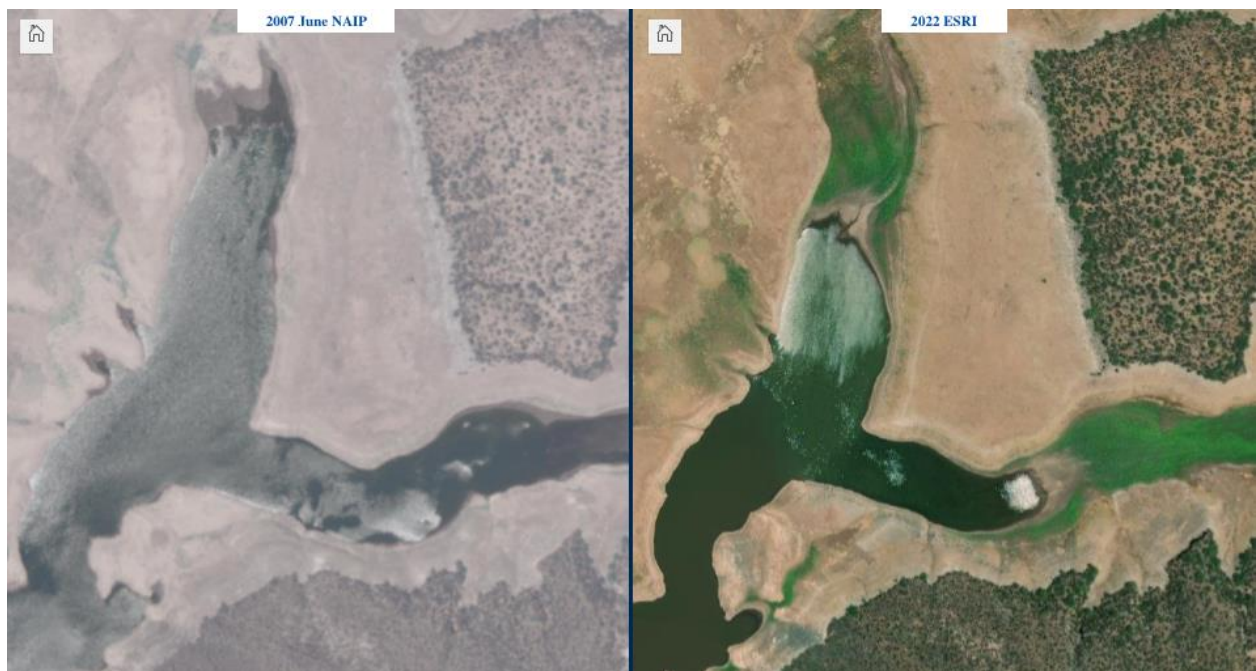
Figure 32. Aerial photograph of Restoration Site F showing low lying parts of the site retaining water even when the surface water elevation of Horseshoe Reservoir pool was much lower than average. In June 2007 (aerial photograph at left), water elevations were at about 594.5 m (1,950 ft). In 2022 (aerial photograph at right), water surface elevations were at 598 m (1,962 ft). Significant parts of Restoration Site F still maintained pooled waters even during these time periods.

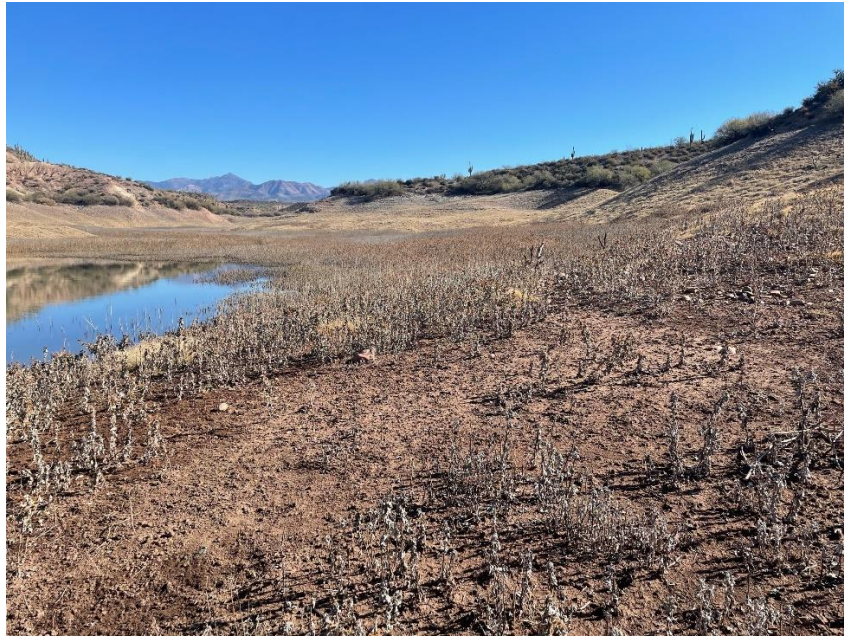
Figure 34. Photograph of Restoration Site F looking due west. Surfaces in the foreground extending away from the reservoir pool are steeper than those to the west (or upstream) of the pool. As such, surfaces in the foreground may be appropriate for obligate riparian and/or non-obligate riparian plants, while the surfaces in the background (as well as surfaces under water at the time the photograph was taken) may be appropriate for native emergent plants.

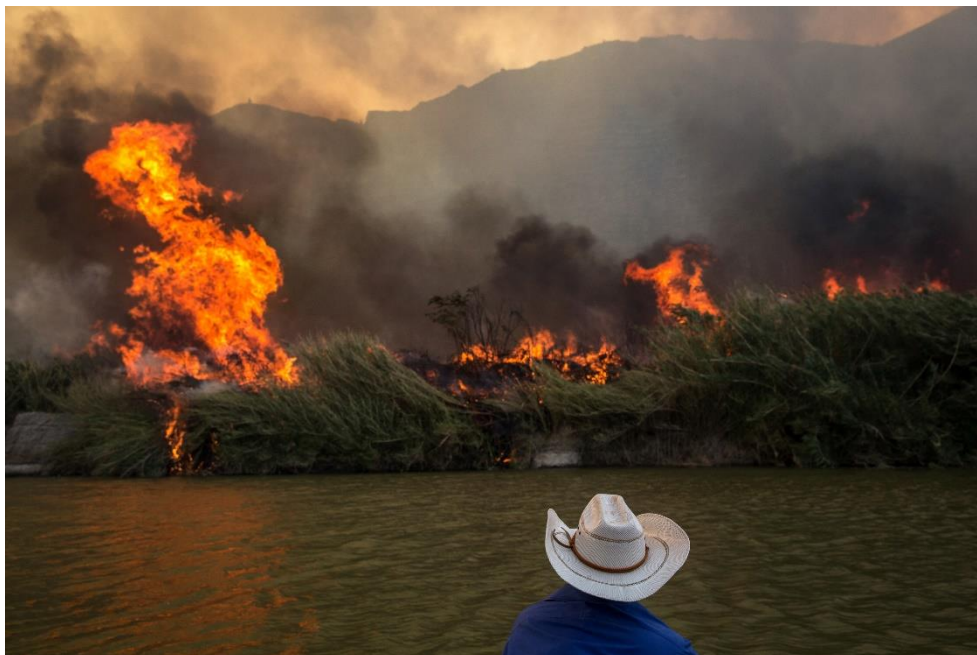
Figure 36. A prescribed burn of giant reed (*Arundo donax*) along the Rio Grande/Bravo in 2018. (Photo by Tamir Kalifa (New York Times)).

While management of established giant cane is challenging, several methods (mechanical, prescribed fire, and chemical) are promising. The overall aim of mechanical cutting and prescribed burning of giant cane is simply to reduce aboveground biomass in a manner that allows more effective subsequent application of herbicide. Mechanical cutting can be carried by using chainsaws or steel blade brush cutters. If access by heavy equipment is possible, mowing or bulldozing may be used. Prescribed burning is conducted during times of year of appropriate weather conditions (dry and warm, with not too much prevailing wind). Prescribed burns can be initiated in a variety of ways, including using fuses or torches. Depending on extent, distribution and density of giant cane, as well as weather conditions, once fire has been initiated, numerous hectares of giant cane can be burned in minutes (Fig. 36).

One of the great advantages of burning – over mechanical cutting – is that practitioners will not have to deal with potentially vast volumes of cut foliage. Both mechanical cutting and prescribed burns typically do not kill giant cane and, actually, can promote significant and rapid re-growth. A month to six weeks after cutting or burning, giant cane will be waist high, but in reduced densities that provide improved access for targeted treatment with herbicide. Not only is herbicide treatment following mechanical cutting or burning more effective, the reduced biomass means less herbicide will be required overall. Foliar applications (i.e., direct herbicide application to leaves) have shown greater success (almost 100 percent) than cut-stem treatments (5 to 50 percent) (Bell 1997). Successful management along the Rio Grande/Rio Bravo has used a combination of prescribed burning with imazapyr application about a month after the prescribed burn is completed, followed by repeat treatment of re-sprouts one year later (Briggs et al. 2021).

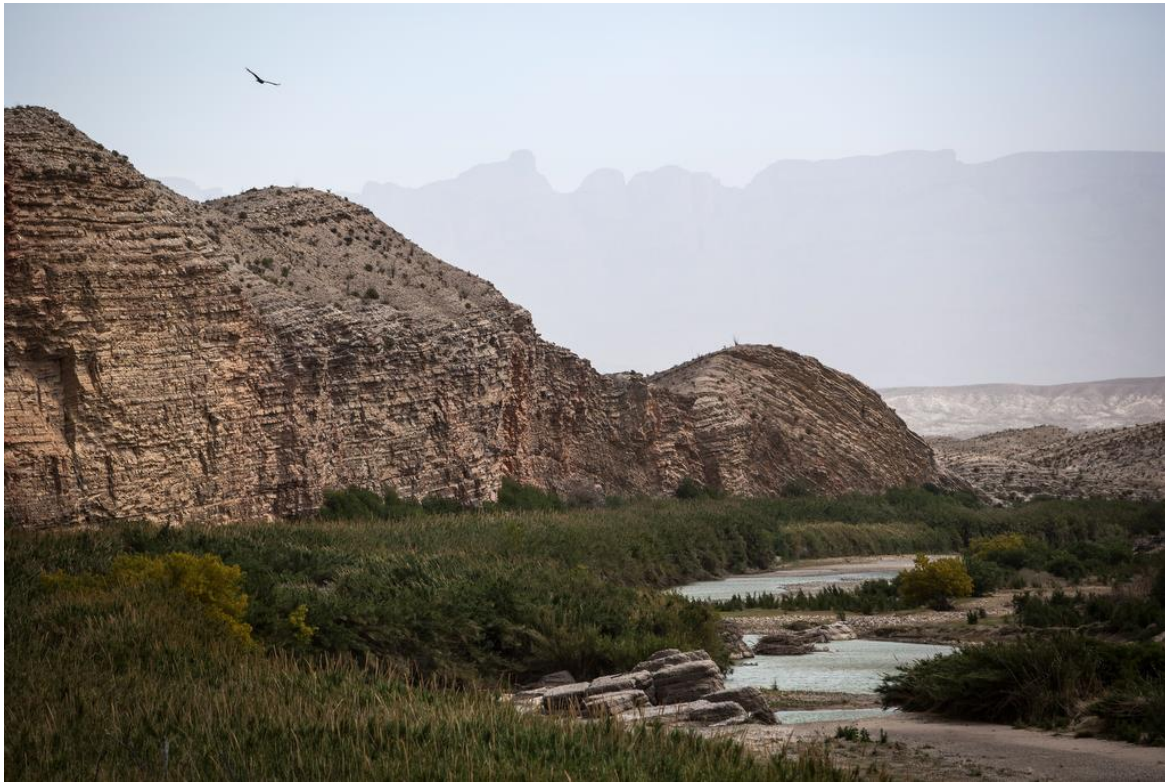
Figure 37. Photograph of a dense stand of giant cane along the international reach of the Rio Grande/Rio Bravo prior to the implementation of management actions. In Mexico, such stands are commonly referred to as milpas (wild corn fields) given their tendency to form dense monoculture stands (photograph by Tamir Kalifa, New York Times).

At this point, giant cane does not appear to be a dominant invasive plant species in the Horseshoe Reservoir study area. This is good news, but SRP should maintain strong vigilance given how rapidly giant cane can establish and expand its extent and distribution. Along the Rio Grande/Bravo downstream of its confluence with the Rio Conchos, the extent and distribution of giant cane went from being present in non-dominate patches to forming monoculture stands along several reaches in less two decades (Briggs et al. 2021) (Fig. 37). Once it has established in such densities, the plant is challenging and costly to eradicate. As such, SRP should endeavor to map the extent and distribution of giant cane (as well as other targeted invasive bottomland plant species) every year. If giant cane is detected, our recommendation is a ‘nip in the bud’ approach that supports a rapid management response that treats establishing Arundo patches with Habitat or other aquatically approved herbicide (with a proven track record of effectiveness in controlling giant cane) as soon as possible following detection.
